## Inspection Report

UNIVERSITY OF WASHINGTON

Type: FOCUSED INSPECTION

Date: 12-JUN-2025

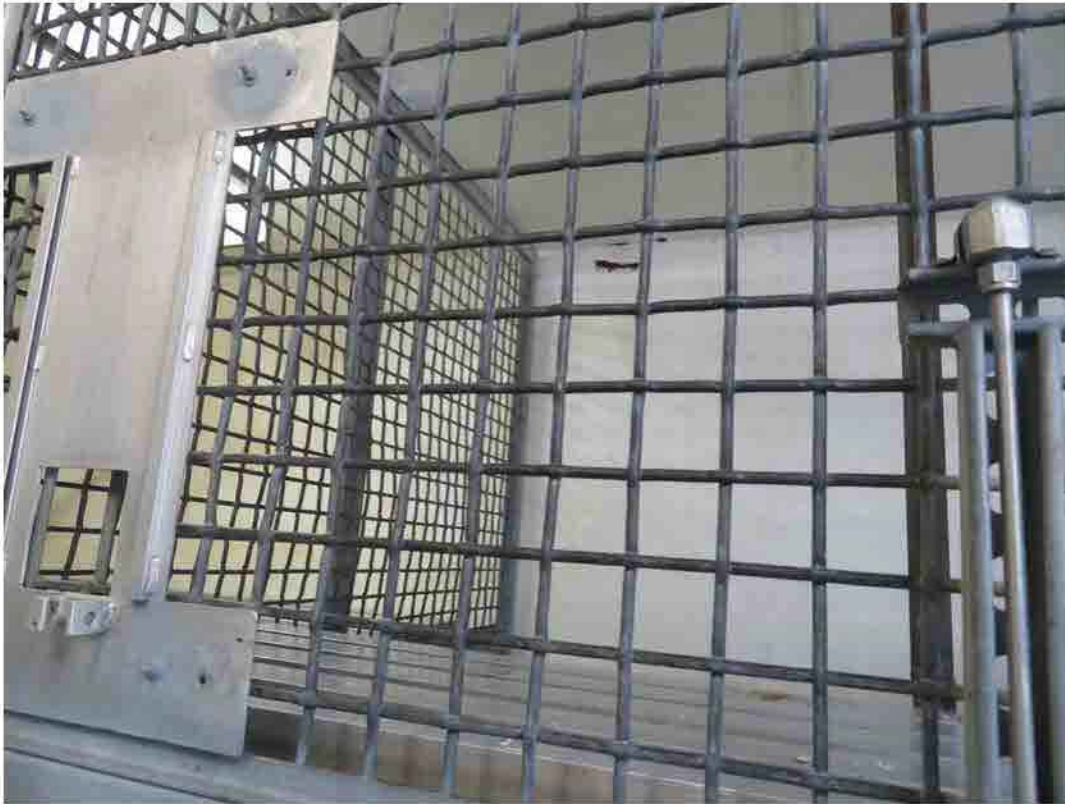
**\*\***There is an approximately 6-inch by 1-inch break in the wall surface of enclosure AA232B, exposing a rusted metal panel beneath. The enclosure is part of a concrete cast sheltered housing facility. This enclosure houses 10 pig-tailed macaques. The facility submitted a work order during the inspection to address the defect. Nonhuman primate primary enclosures that are not in good repair may not protect them from injury, nor allow for proper cleaning and sanitization. Primary enclosures must be designed and constructed of suitable materials and must be kept in good repair. Correct by 27 June 2025.

**Description:** IMG\_2307: This photograph shows enclosure AA232B of a sheltered housing facility that has a defect on the vertical wall near the ceiling observed near the middle of the frame. This enclosure houses 10 pig-tailed macaques at time of inspection.

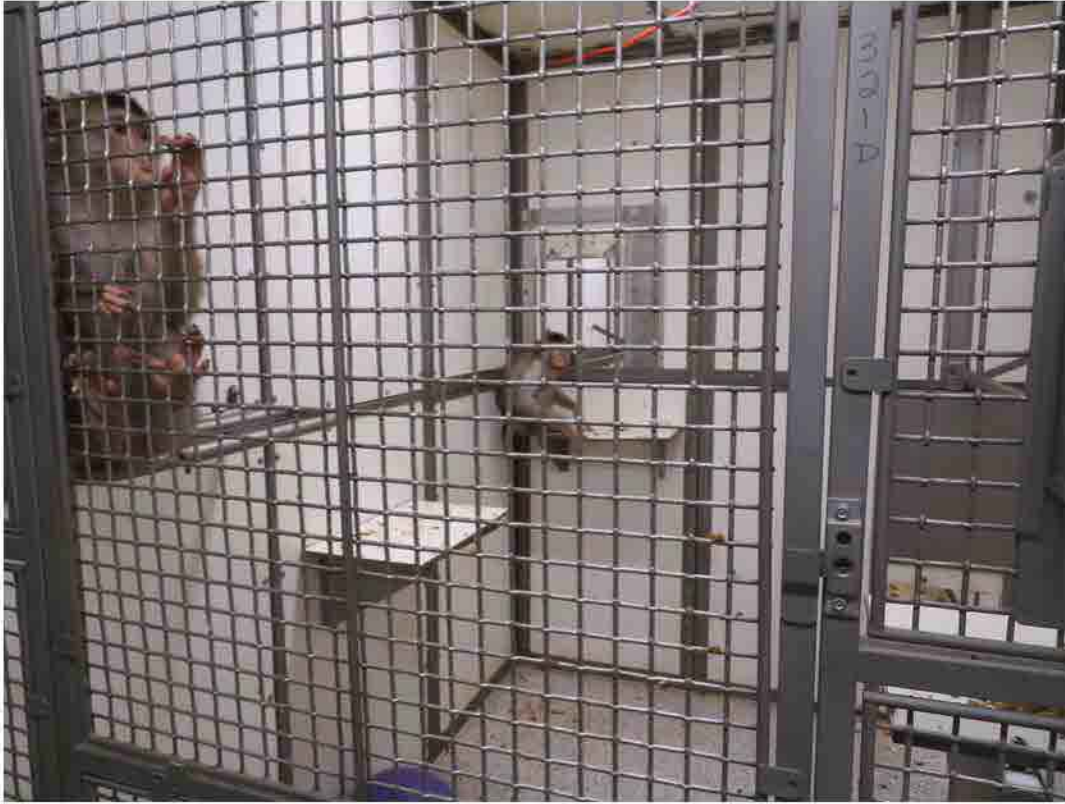
**\*\***A majority of the quadrant style primary enclosures in an indoor facility have at least 1 vertical sliding pulley system door with moderate damage due to use and animal activity. The doors have been retrofitted with a metal footer to restore a flat edge, but roughened surfaces remain exposed. Nonhuman primate primary enclosures that are not in good repair may not allow for proper cleaning and sanitization.

**Description:** IMG\_2305 & IMG 2306 (close up): These photographs show enclosure 321D of a quadrant style enclosure system (one of many) housed within an indoor facility. One photograph shows live pig-tailed macaques present and the other is a close-up of the guillotine-style door with worn and roughened edges that has been patched with a metal footer.

Correct by 31 December 2025.

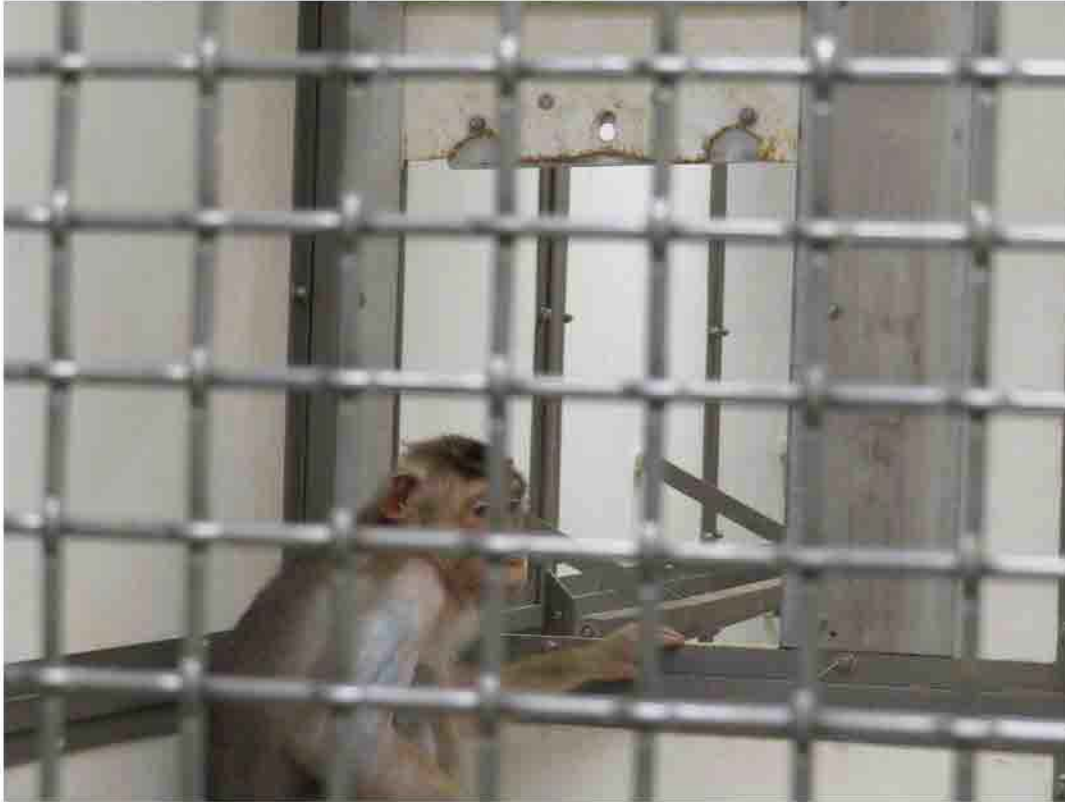
**Description:** IMG\_2305 & IMG 2306 (close up): These photographs show enclosure 321D of a quadrant style enclosure system (one of many) housed within an indoor facility. One photograph shows live pig-tailed macaques present and the other is a close-up of the guillotine-style door with worn and roughened edges that has been patched with a metal footer.

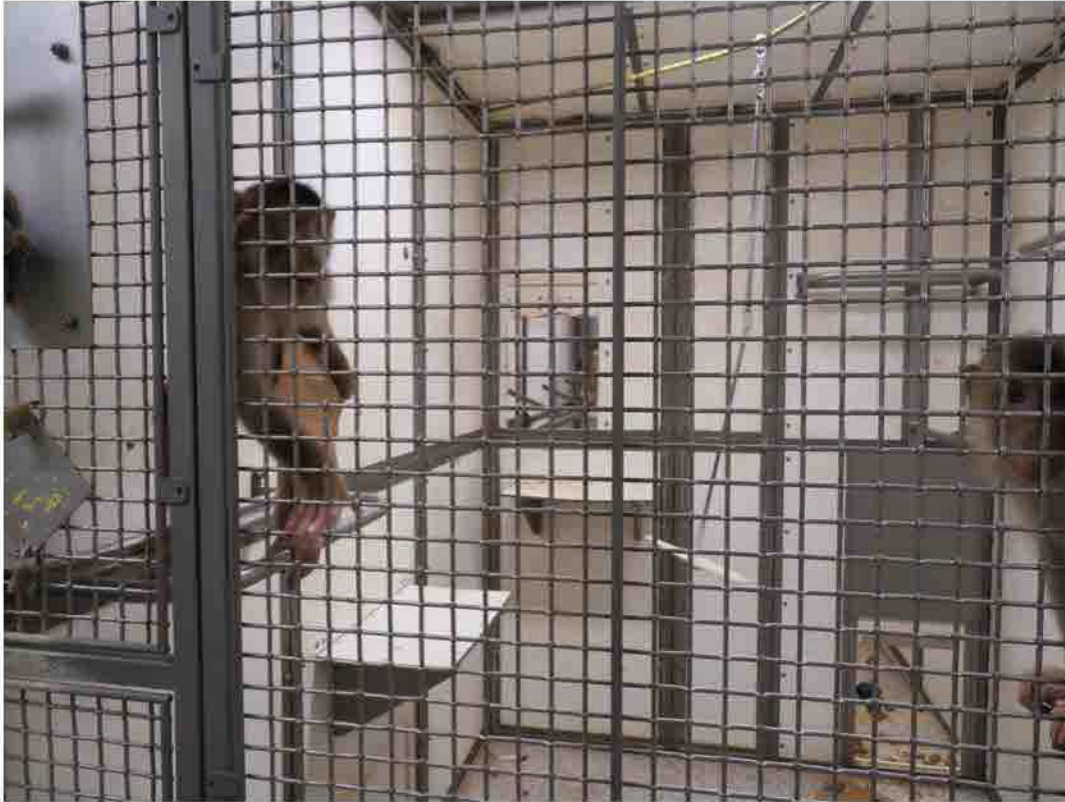
**Description:** IMG\_2285 & IMG\_2286 (close-up): These photographs depict enclosure 308C, part of a quadrant style housing system, within an indoor housing facility (Ellingson Building) where live animals can be seen. The close-up photograph shows detail of the guillotine style door with damage and a retrofitted metal footer.

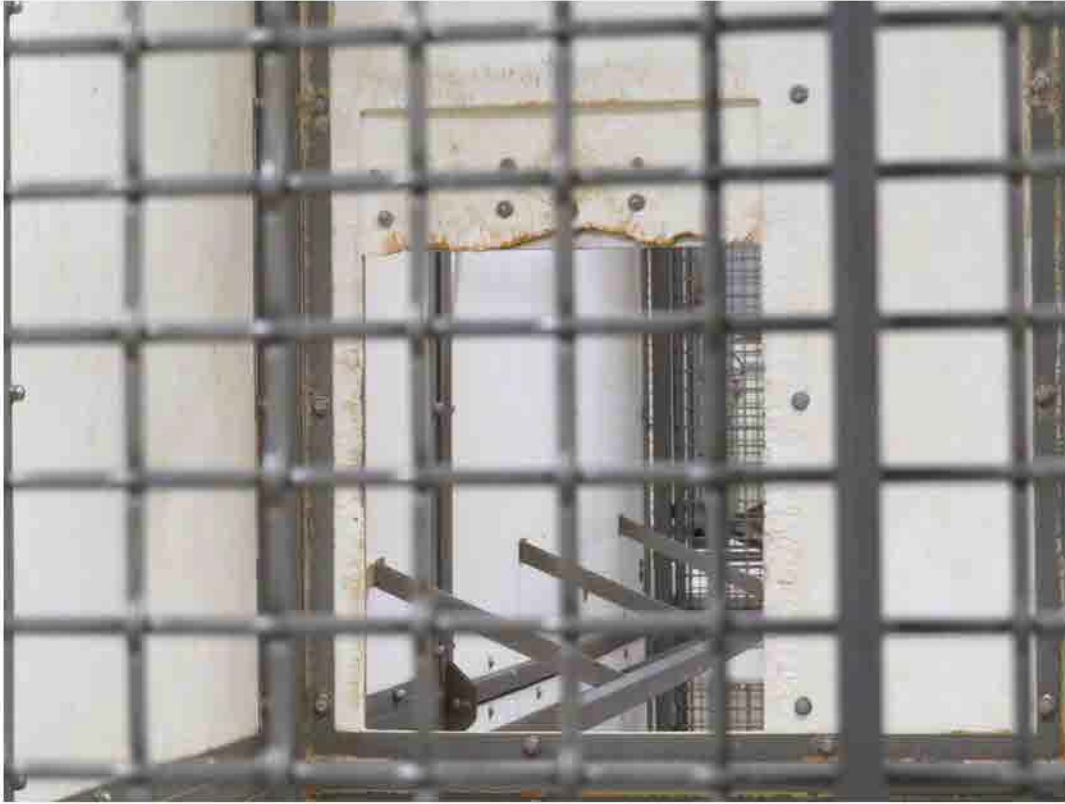
**Description:** IMG\_2285 & IMG\_2286 (close-up): These photographs depict enclosure 308C, part of a quadrant style housing system, within an indoor housing facility (Ellingson Building) where live animals can be seen. The close-up photograph shows detail of the guillotine style door with damage and a retrofitted metal footer.
