Date and Time: 10-DEC-19 Inspection No: 2016082569675041

Certificate: 33-R-0103

Description: KENNELWOOD INC

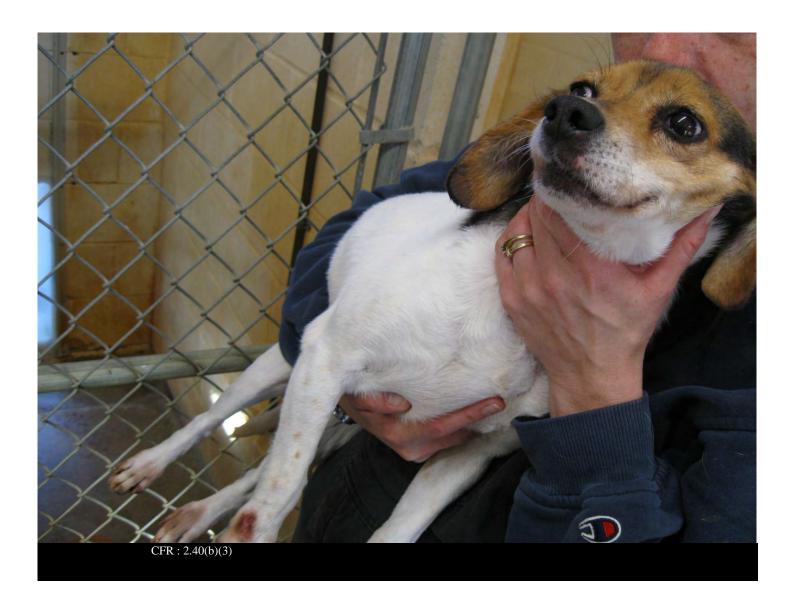
Sheba with dental disease

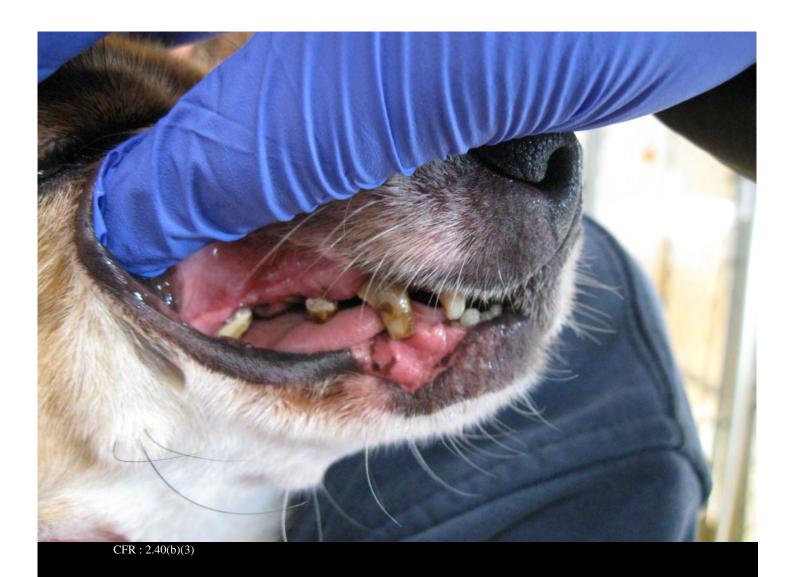
Right jaw - Brown and grey buildup on upper teeth. Cream/tan spongy material in

gum line of two teeth

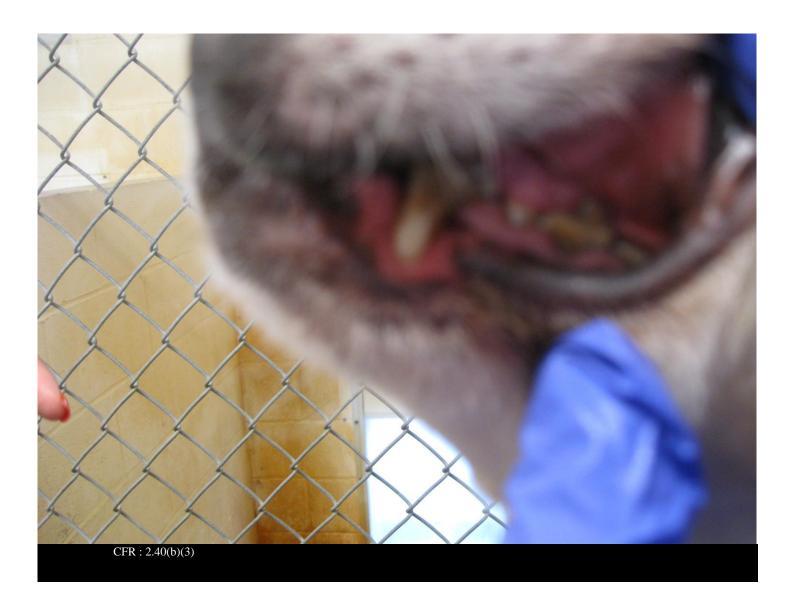
Left Jaw - brown/grey build up on teeth. Some gum recession

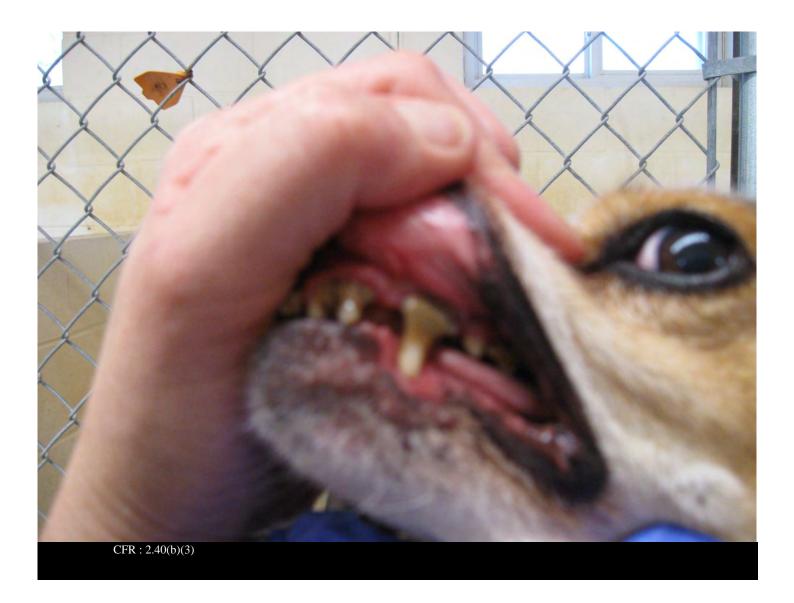
Brown/grey material build up on front teeth

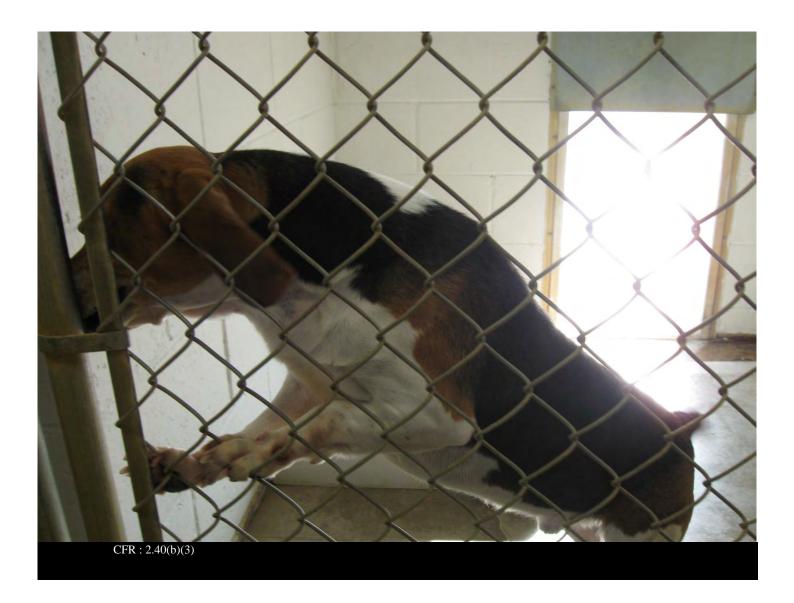
Description: Joey with skin condition

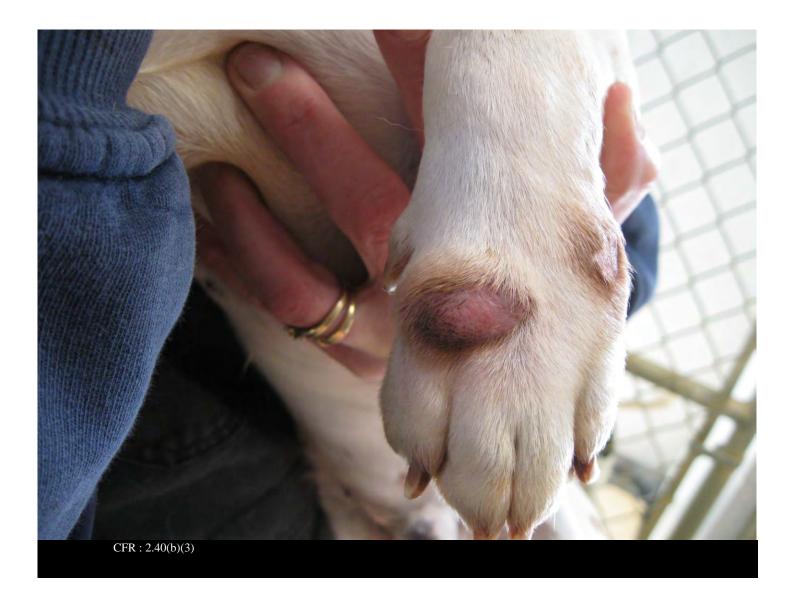
Left paw - hairless region with raised thickened skin

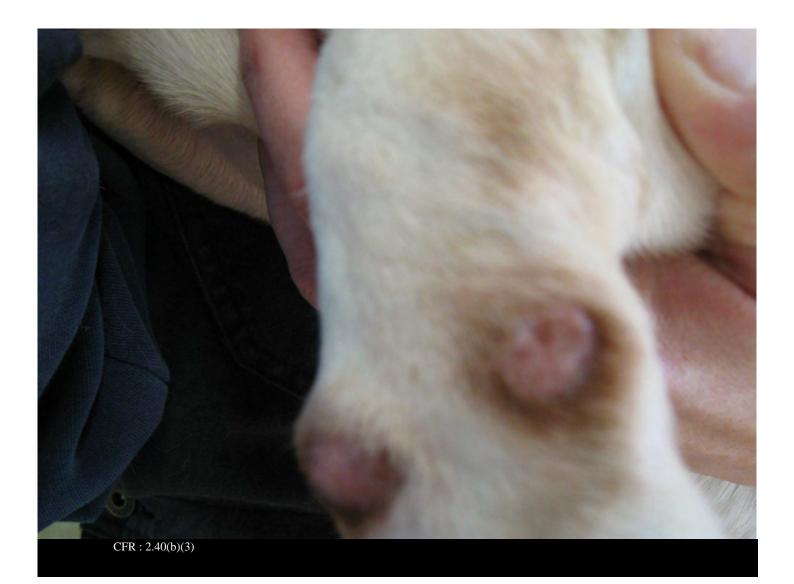
Left paw - hairless region with raised thickened skin. Pinpoint red spots on hairless

region to the left of paw

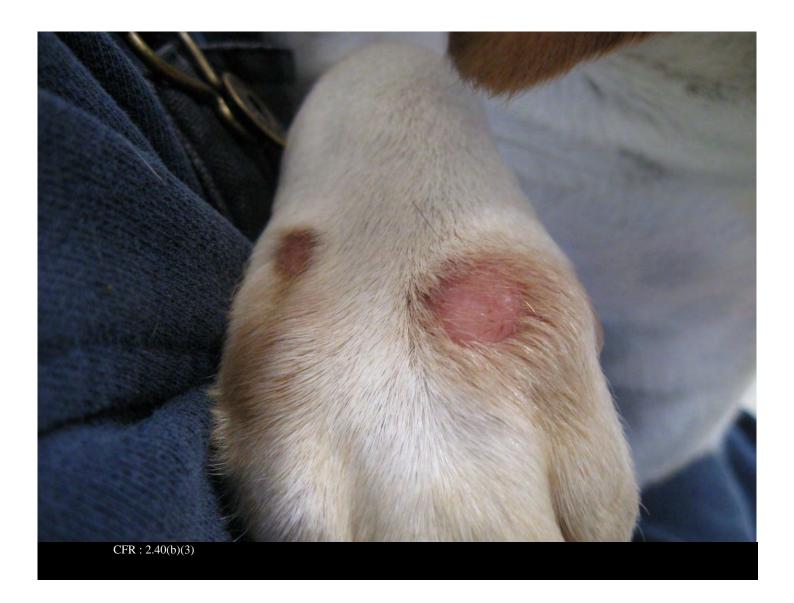
Right paw - 2 hairless regions with slightly thickened skin

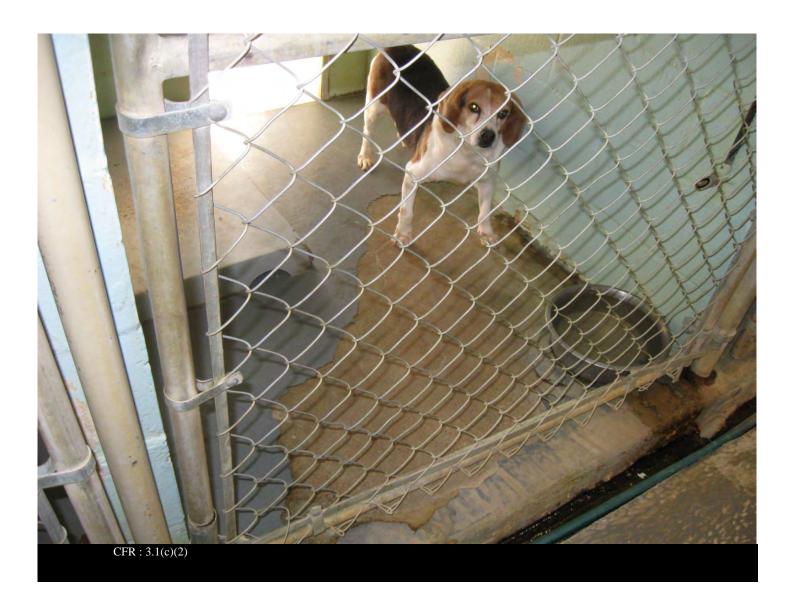
Large gap in material coating the floor

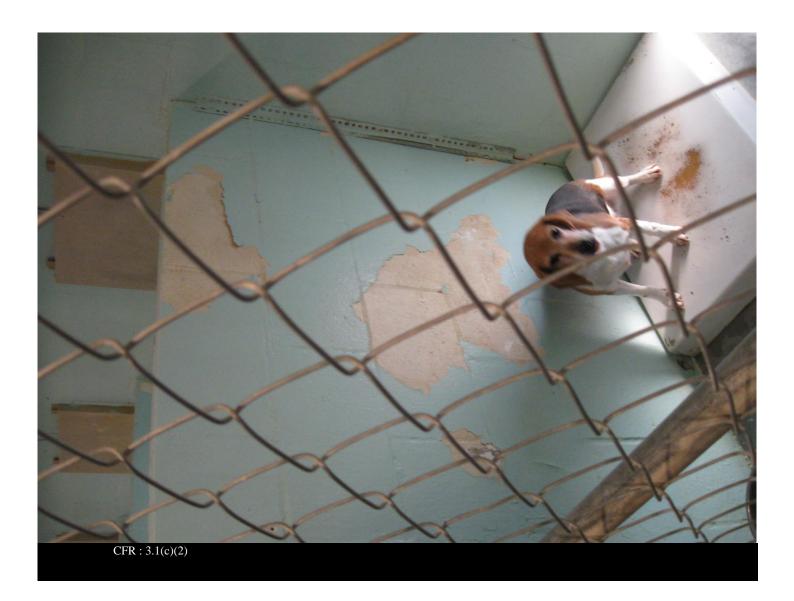
Large gap in material coating the wall

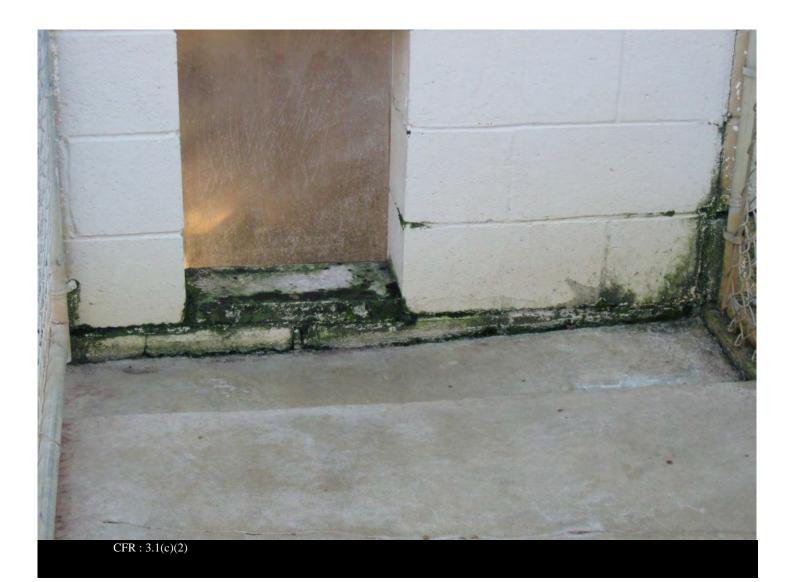
Fuzzy green material on wall below run door

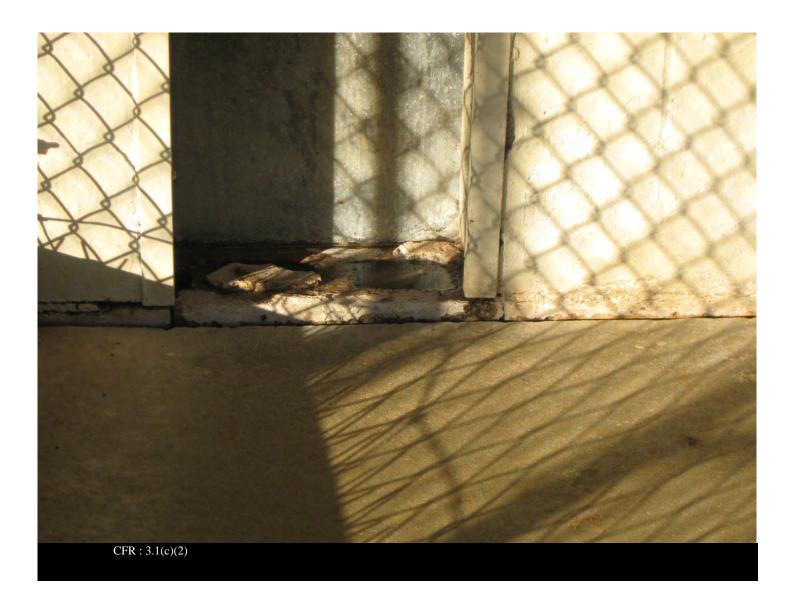
Damaged concrete surface with accumulating water

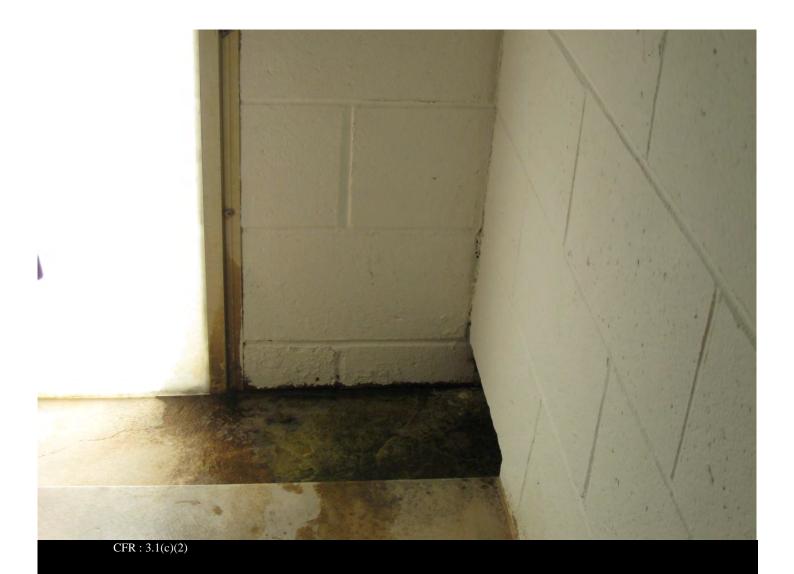
Black green crusty material in depressed area near run door
